# Geotechnical Engineering Report

Cottonwood Residential Development

Walla Walla, Washington

PBS Project HDJ4203.000

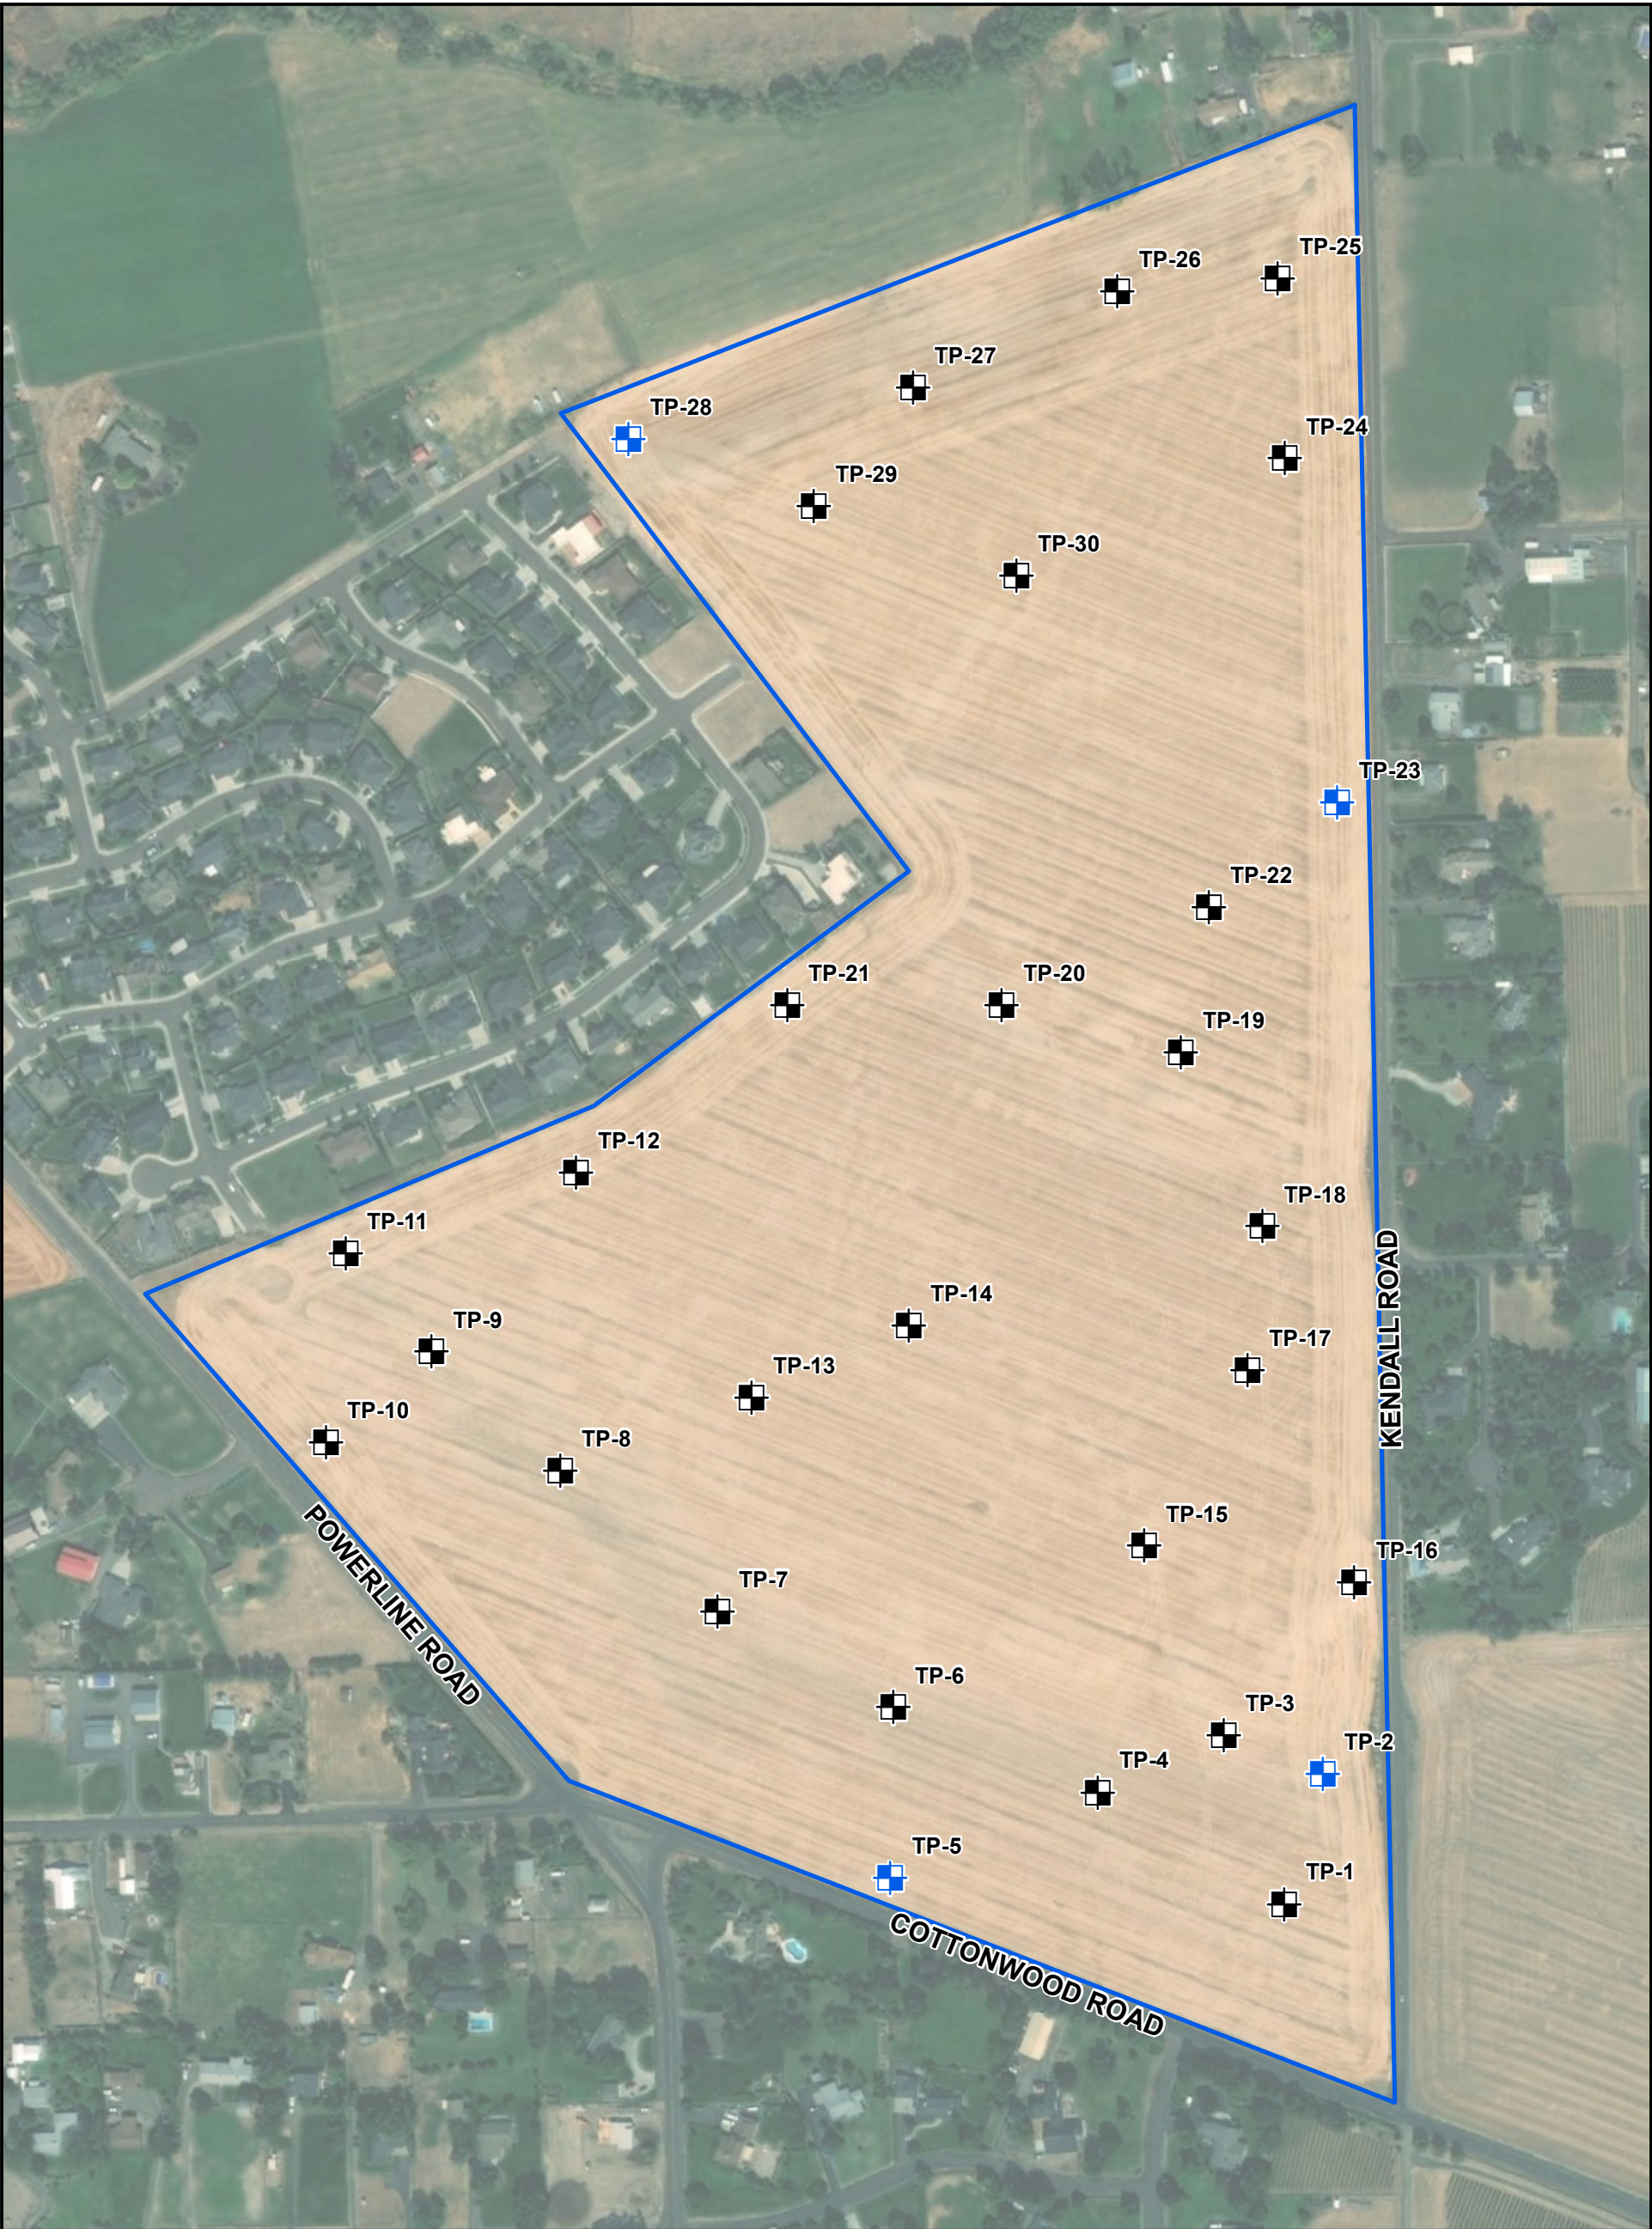
SITE PLAN

- TP-1 - Test pit name and approximate location
- TP-2 - Test pit name and approximate location with infiltration test
- Approximate property boundary

PBS explored subsurface conditions at the project site by excavating 30 test pits to depths of up to approximately 16.5 feet bgs on February 25, 27, and March 1, 2019. The approximate locations of the explorations are shown on Figure 2, Site Plan. The procedures used to advance the test pits, collect samples, and other field techniques are described in detail in the following paragraphs. Unless otherwise noted, all soil sampling and classification procedures followed engineering practices in general accordance with relevant ASTM procedures. "General accordance" means that certain local drilling/excavation and descriptive practices and methodologies have been followed.
